UNITED STATES ENVIRONMENTAL PROTECTION AGENCY
REGION II

DATE: FEB 11 1992

SUBJECT: Site Visit at Proteco, Tallaboa, P.R.

FROM: Phil Clappin, inspector
Hazardous Waste Compliance Branch

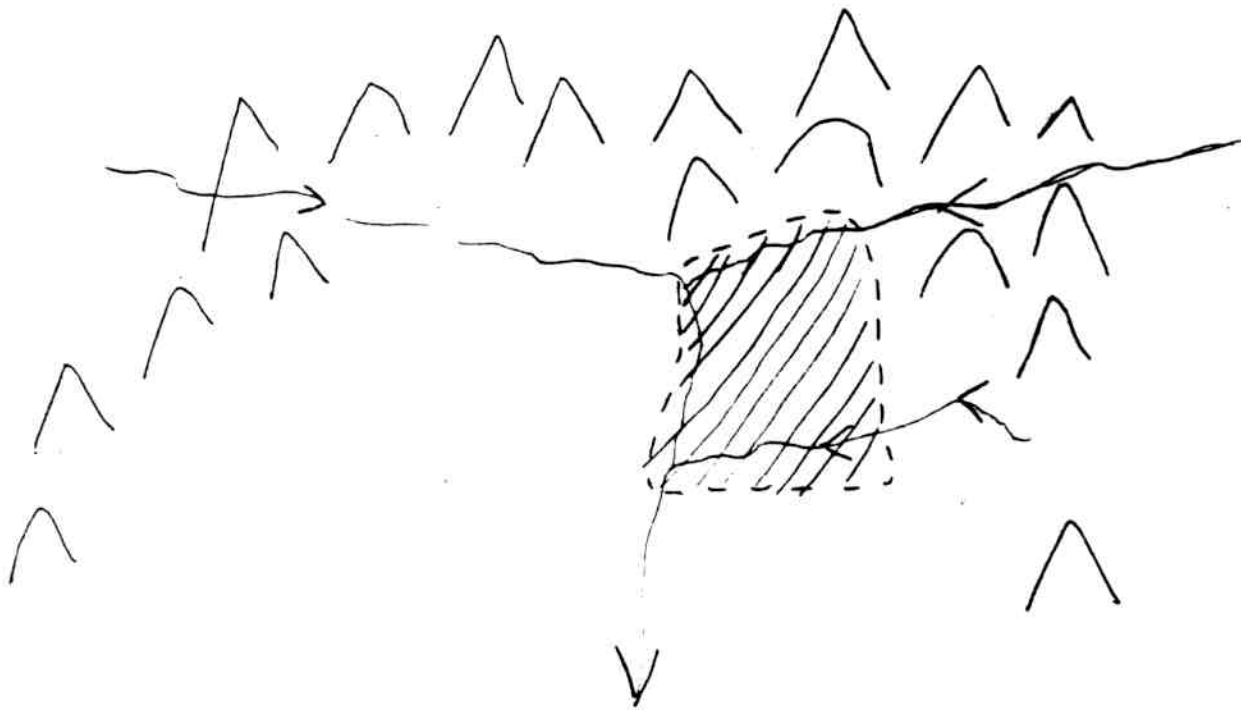
DRAINAGE PATTERN AT PROTECO

The facility is located within a mountain valley about three miles from the Caribbean Coast. It is situated at the confluence of two tributaries of an intermittent drainage channel which runs through the site. At times the streams overflow their banks and flood the land and the road making access to the area where the solid waste landfill is located very difficult. It is not known whether the valley is structurally controlled (fault, joint), related to differential erosion, or whether it was formed solely by the action of the surface water, but it definitely has been enhanced by surface water erosion. Previously, reports have been submitted by contractors which indicate that the soils are relatively impervious (10 to 10 cm/sec), but infiltration must be very high, because the facility representative indicated that by the time the stream flows down the hill leading from the facility it is only a trickle yet it could overflow its banks at the facility.
